Hidden Dangers of Sliding into Curb Incidents on Icy Roads - Look Beyond the Tires & Wheels!

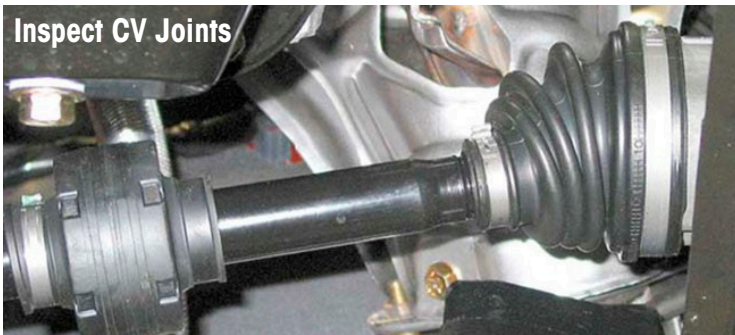
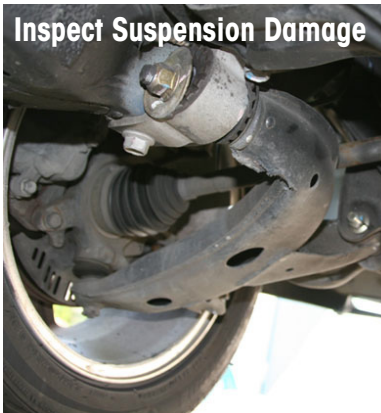
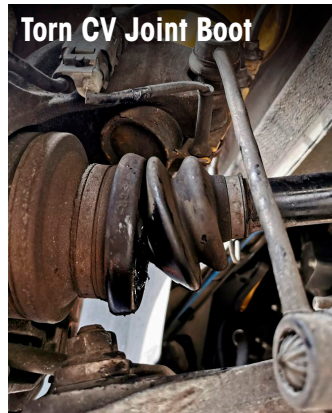
CV (constant velocity) joints and various chassis components, such as control arms, tie rods, and suspension mounts, may sustain damage during a curb impact.

Damage to these components may not result in immediate failure. However, over time, the compromised integrity of the parts can significantly increase safety hazards while driving.

- Inspect the CV joints for any cracks, leaks, or unusual play.
- Check for misalignment or damage to suspension and chassis components such as control arms, tie rods, and ball joints.
- Evaluate the wheel alignment to identify potential bending or shifting of suspension components.
- Replace or repair damaged components as necessary.
- Realign wheels and recalibrate suspension systems to ensure proper handling and tire wear.
